Building Inspection Summary Report

81,000 sq ft Building: (REDACTED), Tacoma, WA 98418

Client: Prospective Buyer - Bank

Inspection Period: Monday, February 26, 2018 through Thursday, March 1, 2018

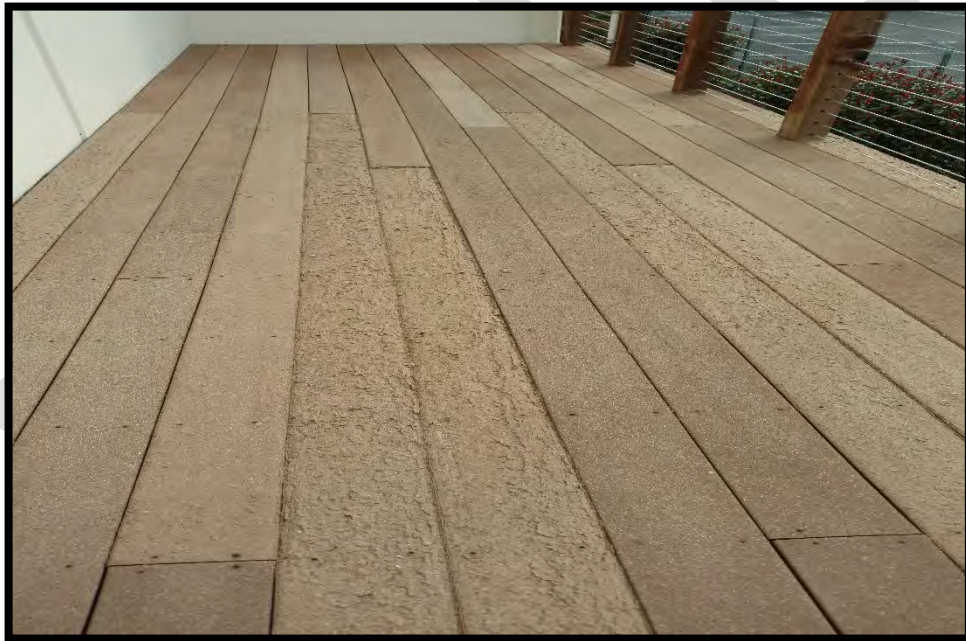
2nd Floor Exterior Deck

Composite decking and handrail degraded, surface is flaking away.

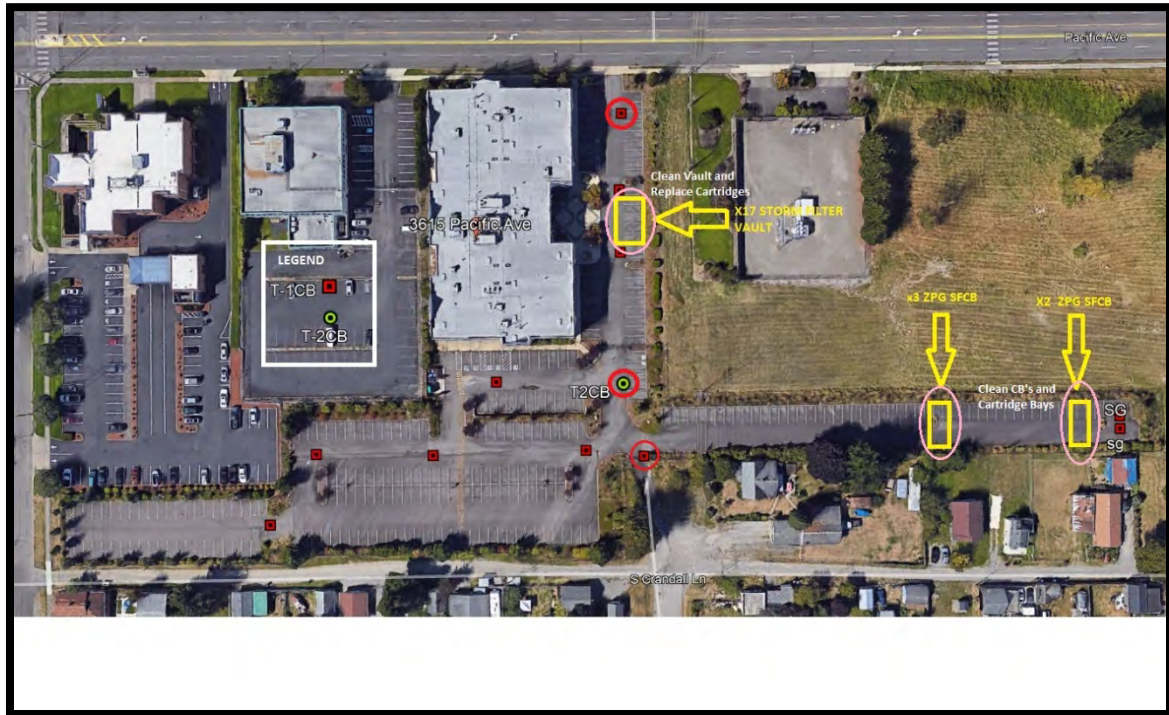
Structures requiring service circled in red for catch basins and pink for Contech. 3 of 13 catch basins need service. 2 of 2 Contech cartridge bays need service. Cartridge vault needs cleaning and Contech cartridge replacement
