Floor Survey Report

2,500 sq ft Tenant Space: Seattle, WA

Client: Prospective Tenant - Restaurant

Inspection Period: Monday, May 30, 2022

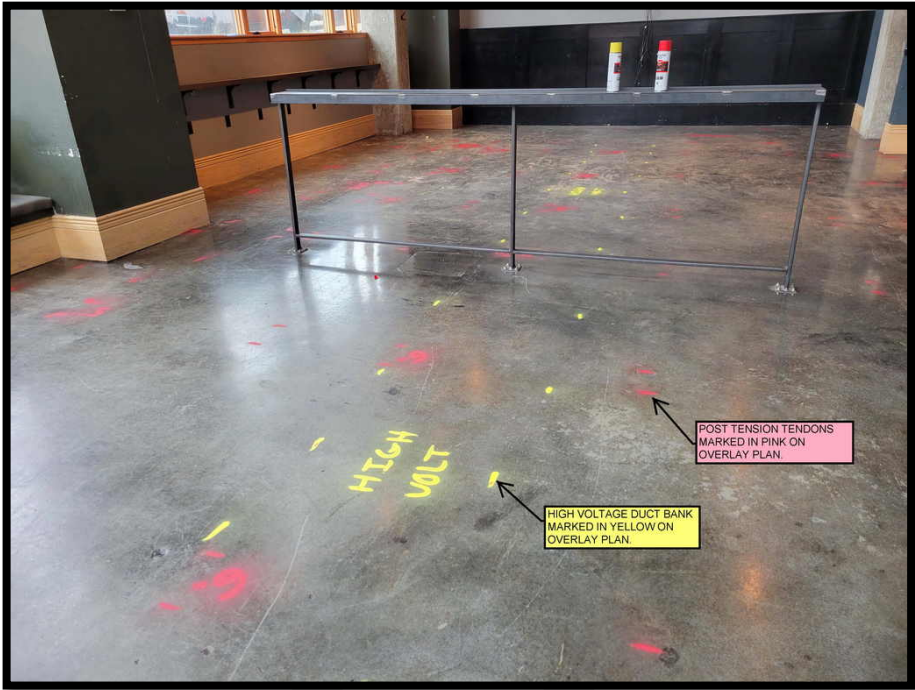
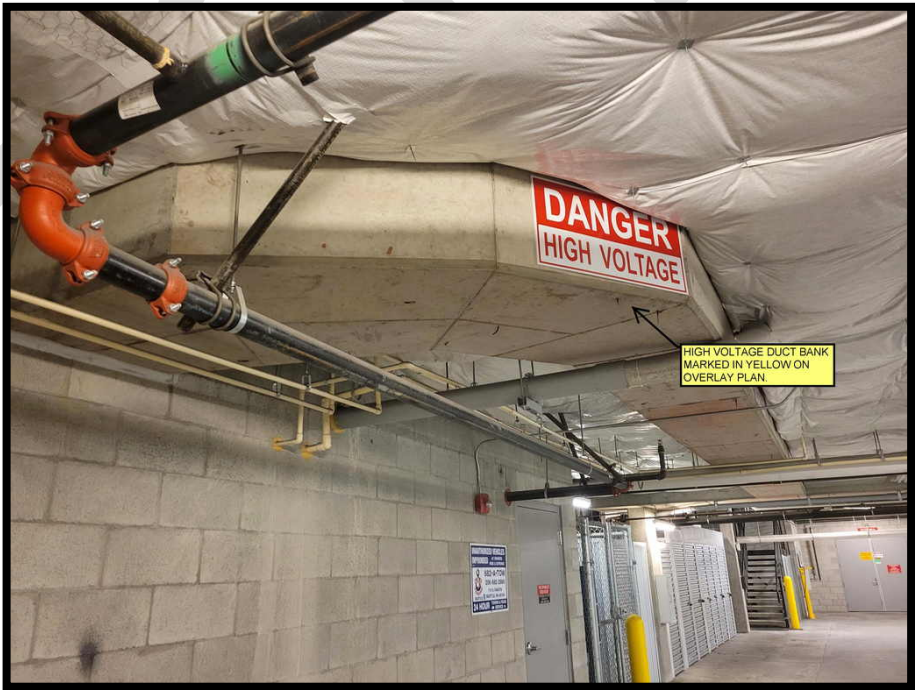
Electrical Duct Bank Photos Follow

In the process we also located the main building power duct bank entrance and traced its path through the tenant space. The overlay plan and photos attached to this report represent the full work product of this site survey to accurately locate the post-tensioning cables and the electric power duct bank.
