Building Inspection Summary Report

81,000 sq ft Building: (REDACTED), Tacoma, WA 98418

Client: Prospective Buyer - Bank

Inspection Period: Monday, February 26, 2018 through Thursday, March 1, 2018

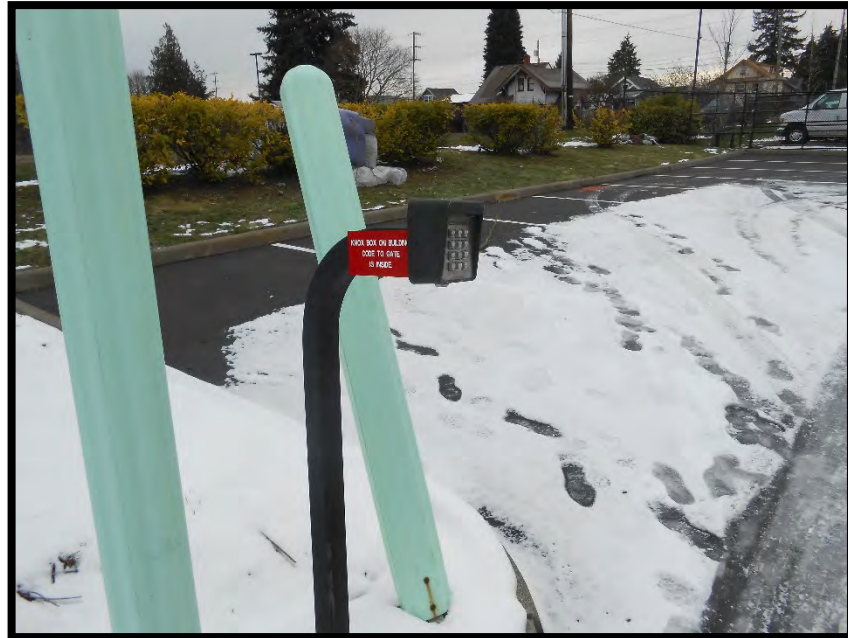
The parking lots have been freshly seal coated, re-striped, and new ADA markings applied. There is an electric gate controlled by a keypad that separates the entry (north) parking lot from the east lots. A portion of the east parking lot is rented or leased for the Pierce County Public Health motor pool.
